Reduction and Control of Sediment-Laden Runoff to Coastal Waters through the Implementation of Best Management Practices (BMP's), Coastal Habitat Rehabilitation and Delimitation of Public Access at Culebra, Puerto Rico

FINAL REPORT

August, 2015

*Projects toward the implementation of the Culebra
Community Watershed Action Plan for Coral Reefs and Water Quality*

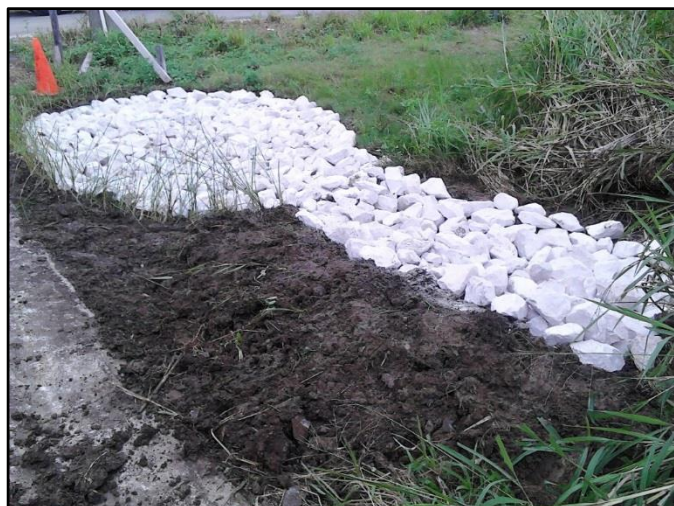
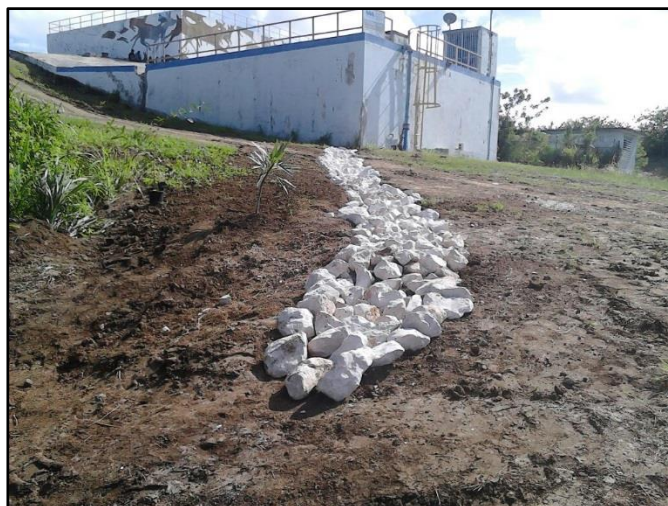
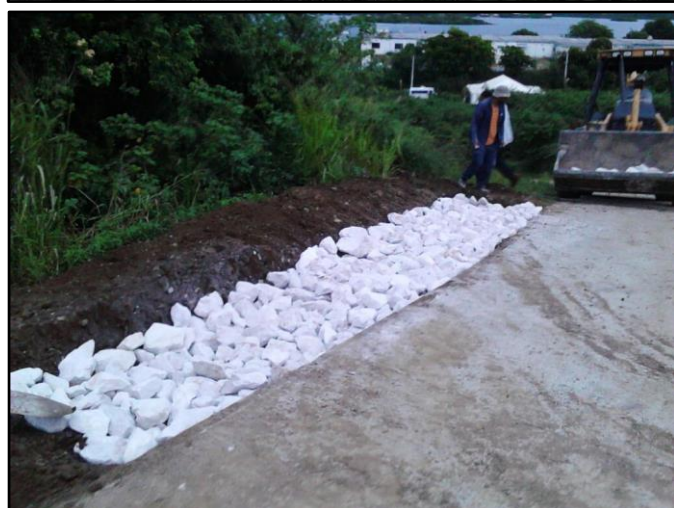
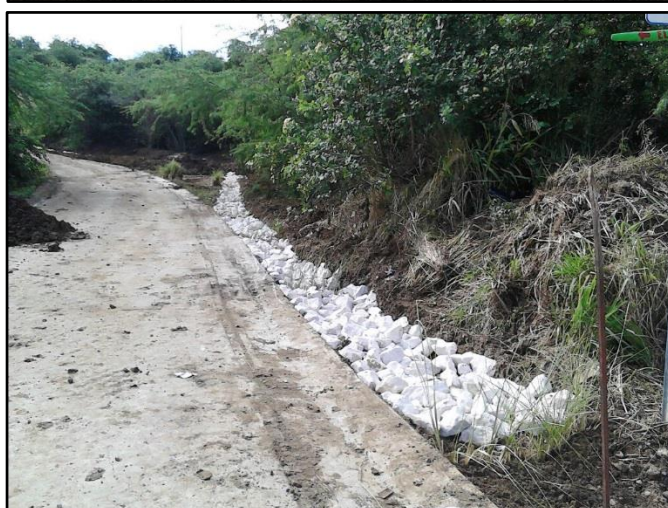
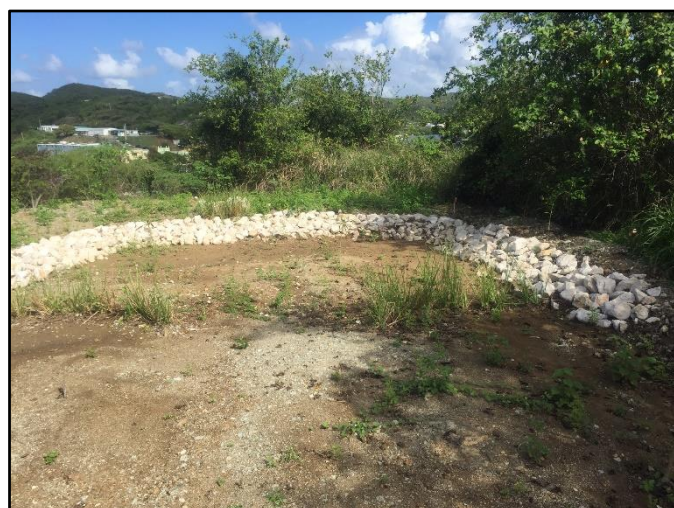
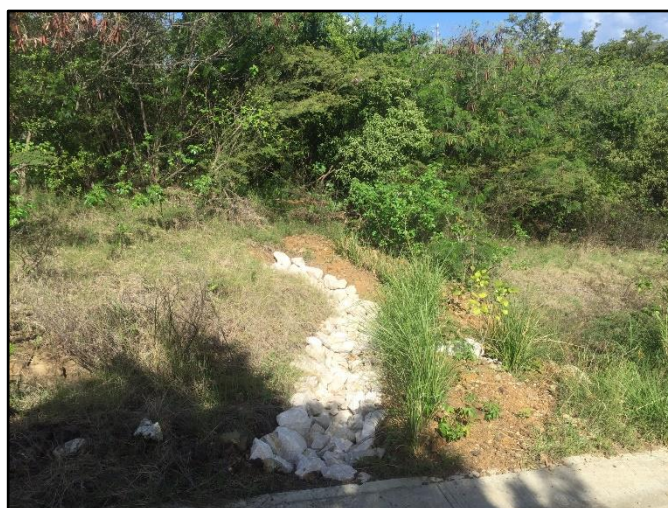
Figure 31. Town site after implementation.

In order to be able to stabilize this site, a series of components were constructed to increase the effectiveness of the conservation practices implemented and help reduce sediment transport to the Lobina channel and the nearshore reefs (Figure 29). A total of three rain gardens/sediment traps were constructed. The project resulted in over 150 native trees and 1000 Vetiver plants being planted to help stabilize conveyances and re-establish native vegetation. Cross swales and a series of check dams with riprap and Vetiver were established to redirect runoff to the rain gardens and reduce the energy of the water. An infiltration gallery was created to address runoff from an uncontrolled drainage area from the overflow of the water reservoir tank (Figures 30 and 31).
